CONTROLLED DEMOLITION OF AN UNBONDED POST-TENSIONED CONCRETE SLAB

BY FLORIAN G. BARTH
AND BIJAN O. AALAMI

Synopsis: This report describes the controlled demolition of 100,000 square feet of post-tensioned slab, which was necessitated by suspicion of damage due to fire. The saw cutting procedure was used to neutralize over 900 post-tensioned tendons. The neutralization of the tendons was programmed to reveal information on response of live and in-place tendons to saw cutting. Observations made are described and tabulated. Steps taken to integrate the retained portions of the building with new construction are described. The work illustrates that, if required, slabs constructed with unbonded post-tensioned tendons can safely and readily be dismantled. The report concludes with recommendations for demolition of similar projects.

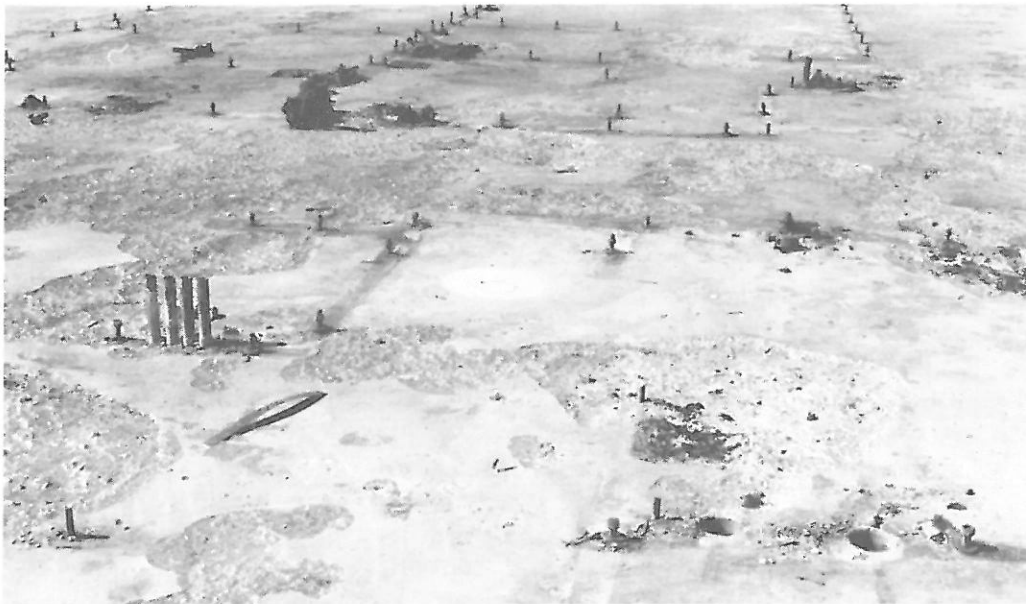
It was observed that spalling and disintegration of concrete over the top of slab was concentrated in patches. It was most severe at midspans and away from the column or wall supports. At these locations there were few, or no reinforcement at the top of slab, and the slab surface was in compression. Over the columns and the walls the concrete appeared to retain its integrity. The locations of columns and wall supports marked on the slab surface confirmed this observation (refer to Pictures 1, 2 and 3).

PICTURE 1: CONCRETE SPALLING IS MORE PRO-
 NOUNCED AT MIDSPANS AWAY FROM COLUMNS AND
 WALL SUPPORTS.

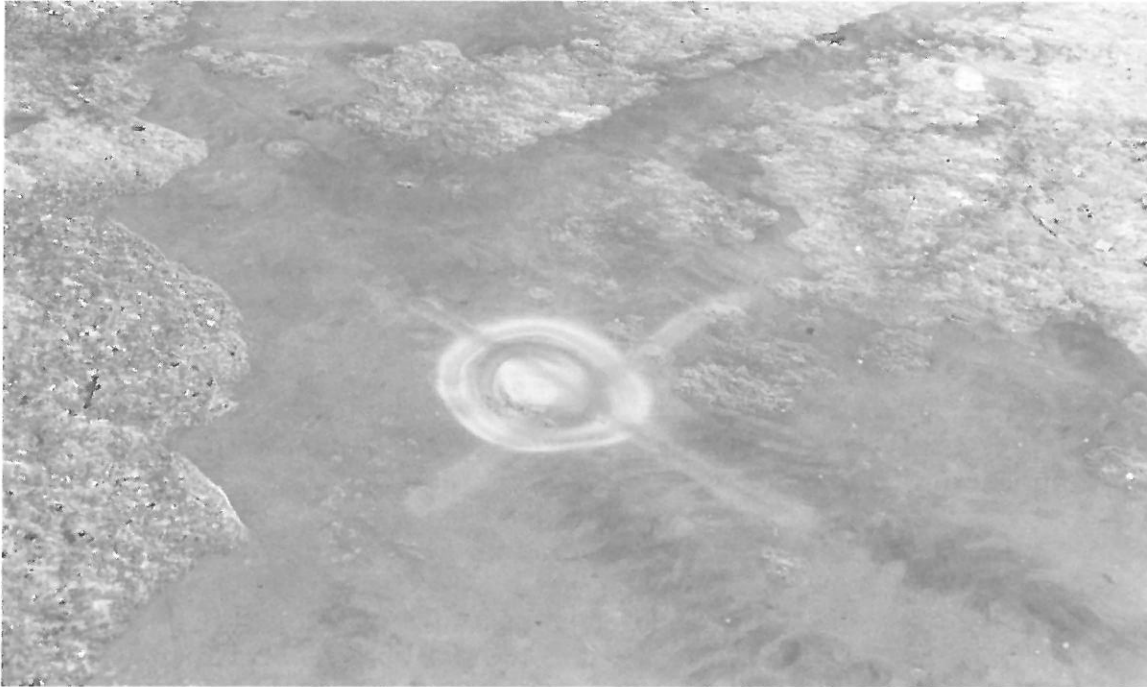
PICTURE 2: COLUMN LOCATIONS ARE MARKED ON SLAB SURFACE. CONCRETE DETERIORATION IS MINIMUM OVER COLUMN SUPPORTS.

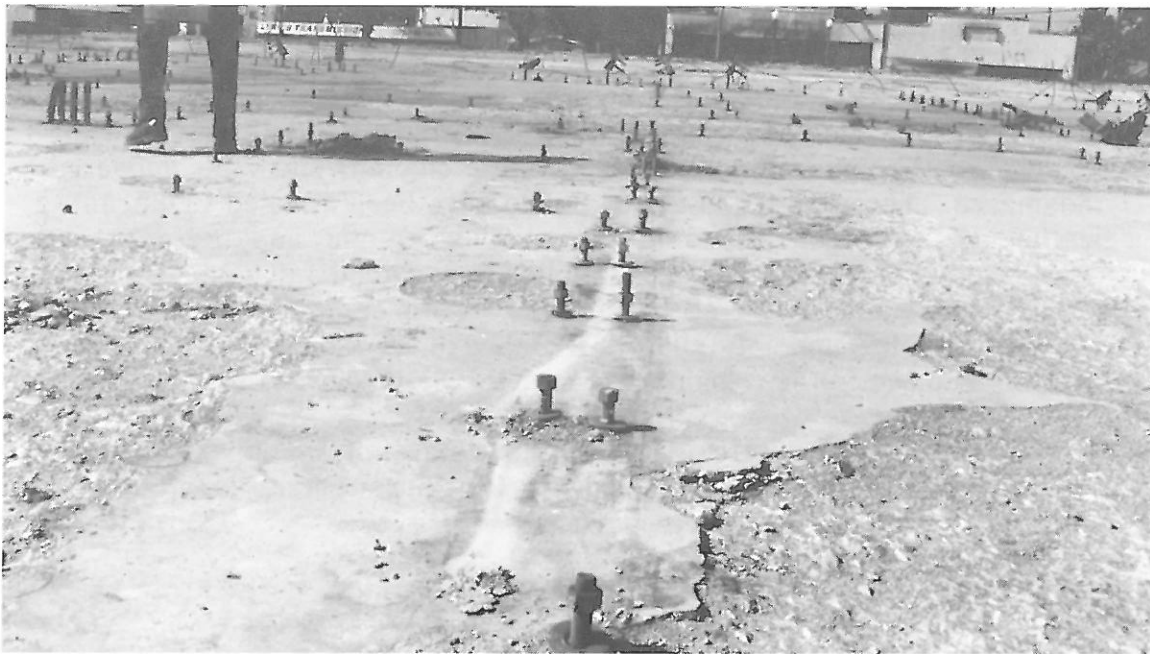
PICTURE 3: REMAINS OF ANCHOR BOLTS AT LINE SUPPORTS. OBSERVE CONCRETE SPALLING AWAY FROM THE SUPPORT LINE.

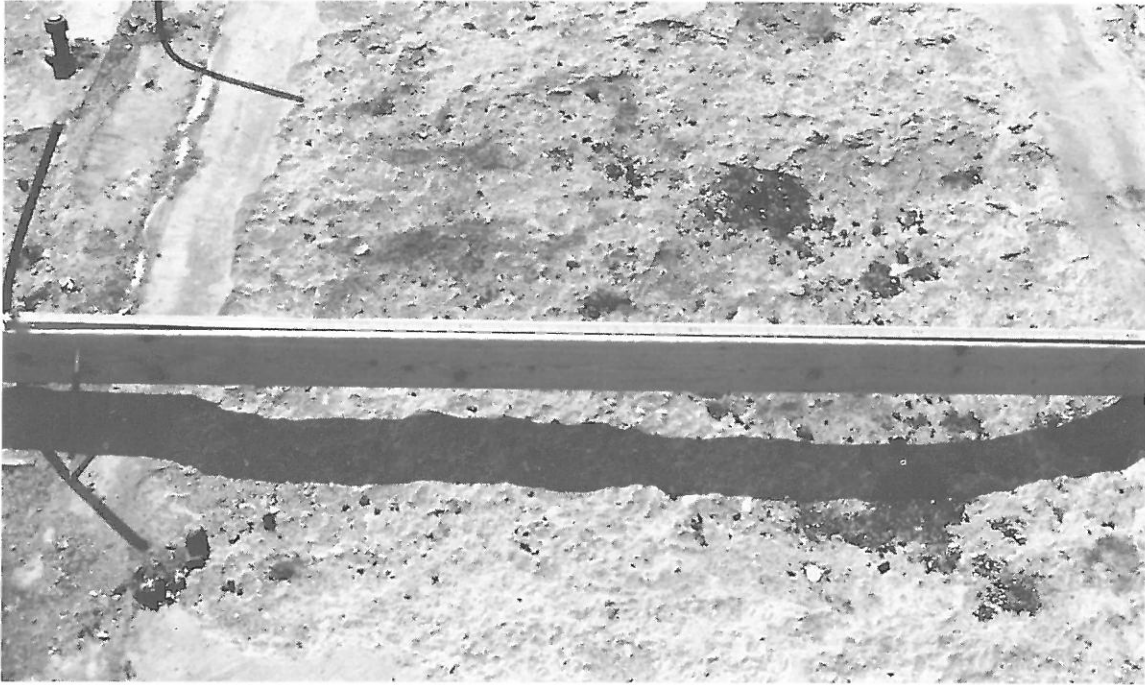
At locations the depth of spalled concrete reached three inches. (See Pictures 4 and 5).

PICTURE 4: LOCAL CONCRETE SLAB SURFACE CONDITIONS AFTER REMOVAL OF WOOD REMAINS.

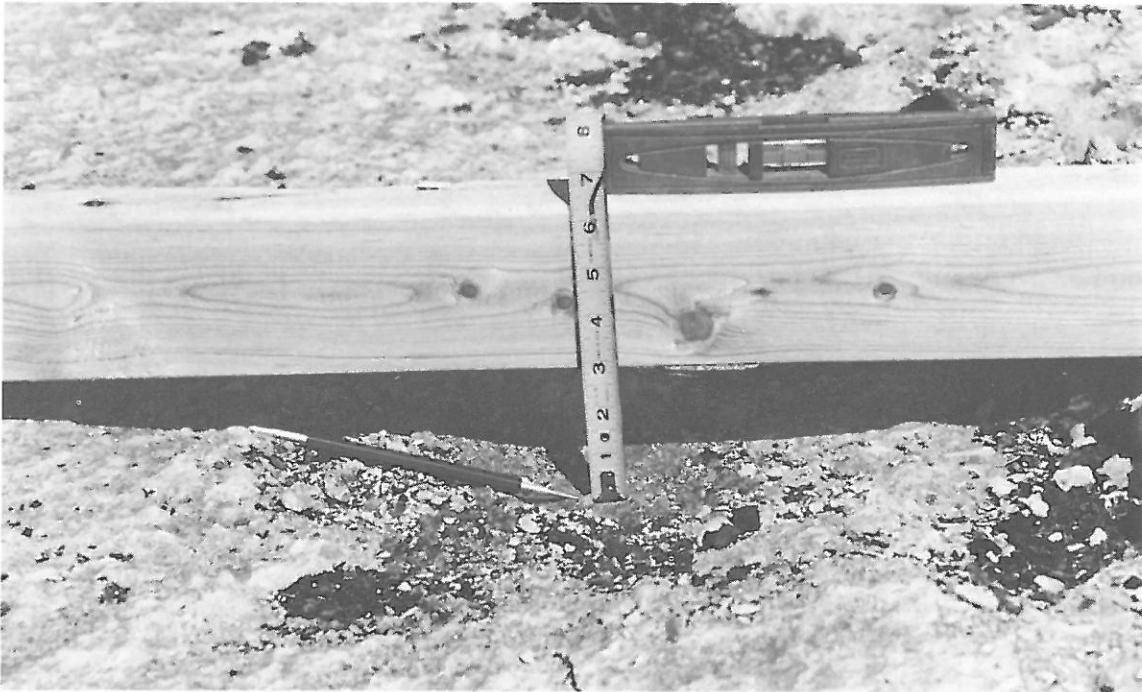
PICTURE 5: SLAB SURFACE SHOWED LOCAL DISINTEGRATION OF CONCRETE UP TO THREE (3) INCHES.

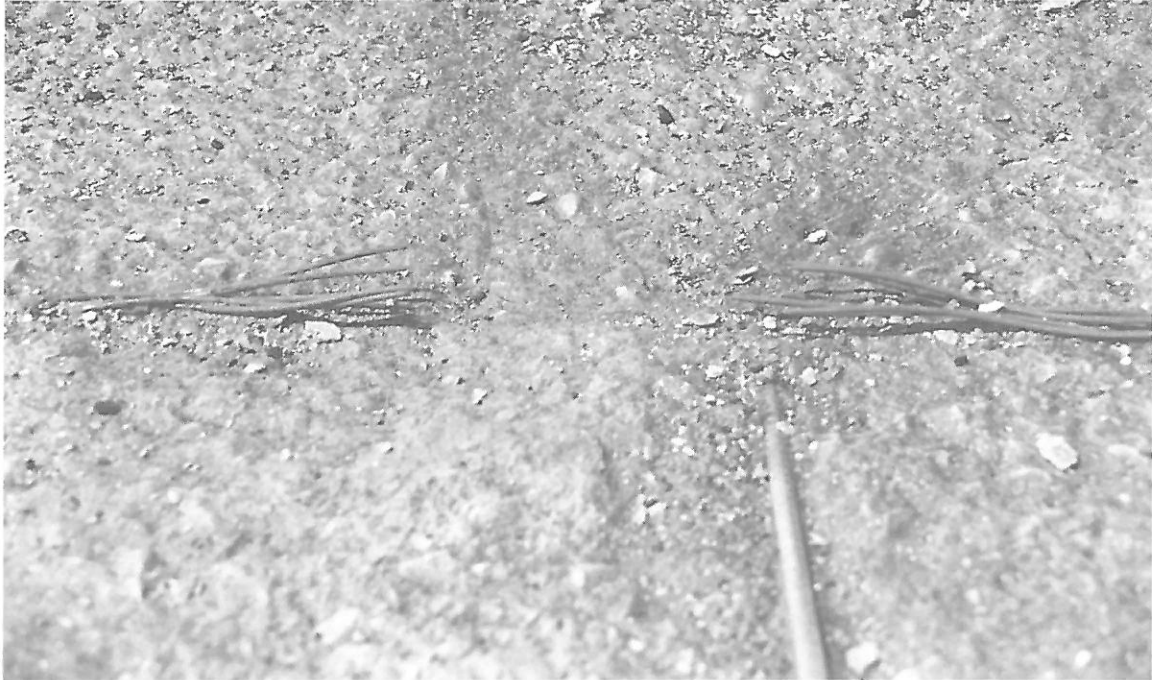
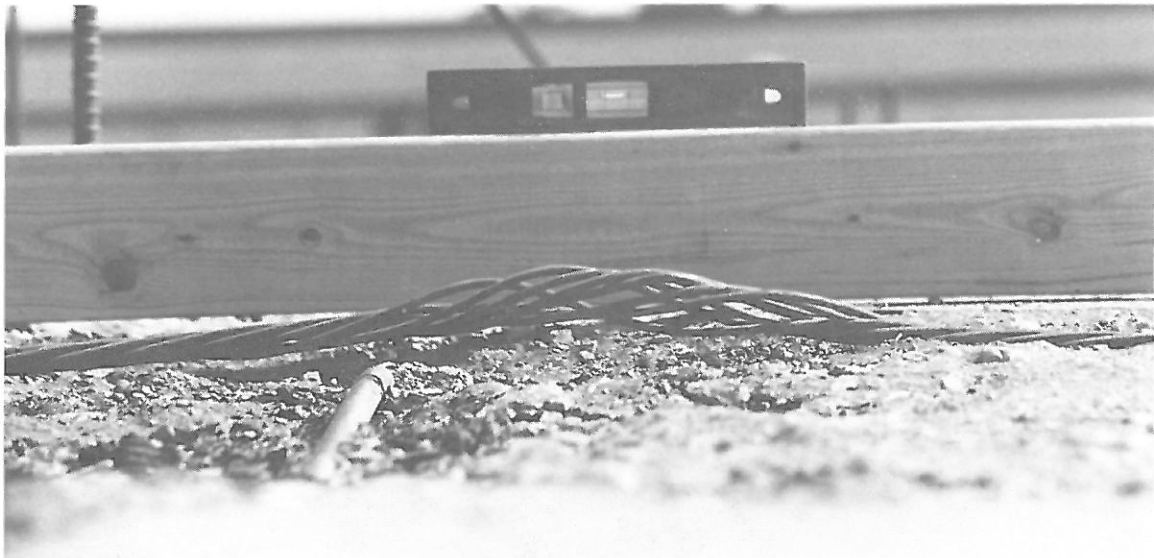
A search over the slab surface and along the exposed slab edges indicated that approximately 3% of the tendons were ruptured. These either protruded from the top of slab, or had their tails dislodged at the slab edge. It appeared that the failed tendons were limited to the distributed strands, and that the failure occurred at the high point of the tendon where the cover was least. (See Pictures 6 and 7).

VISUAL INSPECTION INDICATED THAT 3% OF STRANDS WERE DAMAGED DUE TO FIRE. THE OBSERVED DAMAGED STRANDS WERE ALL DISTRIBUTED TENDONS.

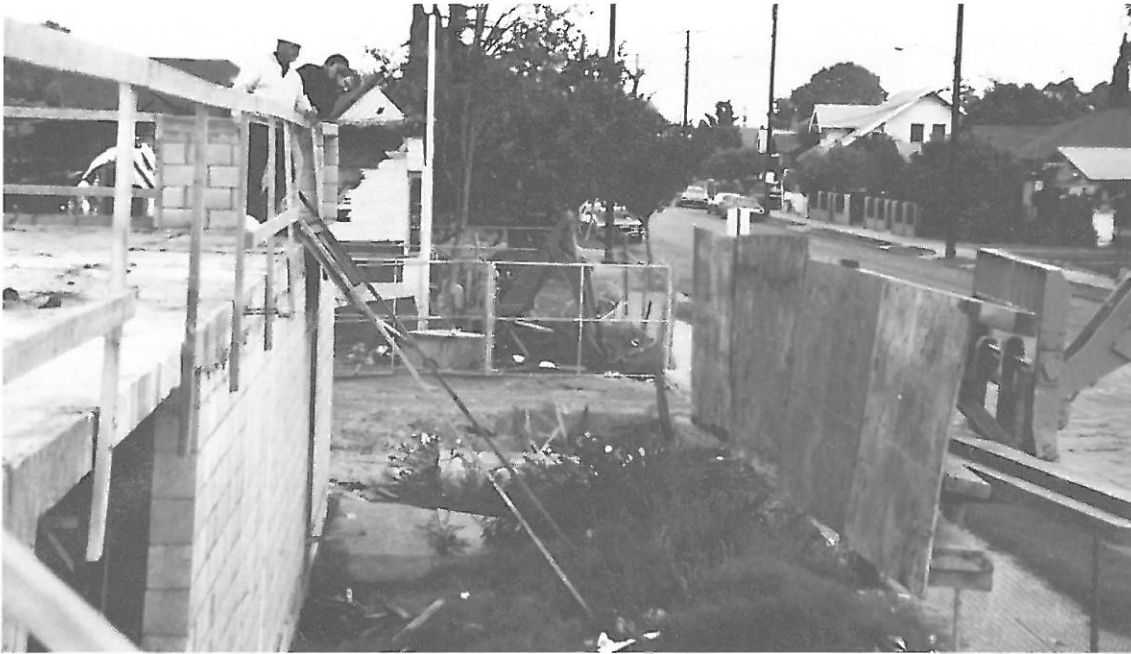
PICTURE 10: PLYWOOD SHIELD RAISED WITH A FORKLIFT TRUCK AND HELD IN LINE OF THE STRANDS BEING CUT.

pieces which became loose (see Picture 10). Recommendations called for sandbags at interior openings, such as stair or elevator shaft, placed at slab edge over the tendon stressing end.

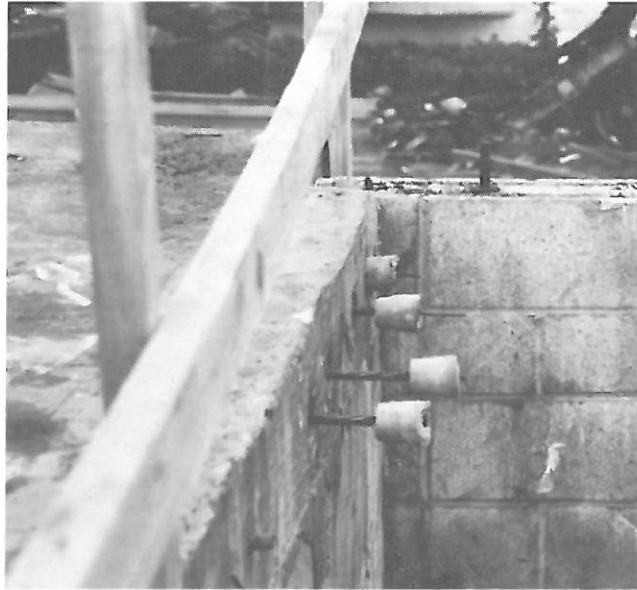
During the demolition of this project 962 tendons were cut with 1002 stressing ends at free slab edges. Only at 203 locations did the tendon tail/grout plug exit the slab edge at the stressing ends. No tendon tail/grout plug exited the slab edge more than 18 inches. In almost all cases the anchorage assembly remained intact. In only 12 percent of the tendons which exited at the slab edge, the bond between the grout plug of the recess block and the strand tail broke. In such cases, the pieces fell off about 3 feet from the slab edge. In no case did a wire or strand become detached from its duct to fall off the slab. Pictures 11, 12, 13 and 14 illustrate the slab edge where tendons dislodged after cutting the tendons.

PICTURE 11: SLAB EDGE CONDITION AT LOCATIONS OF DISLODGED TENDONS.

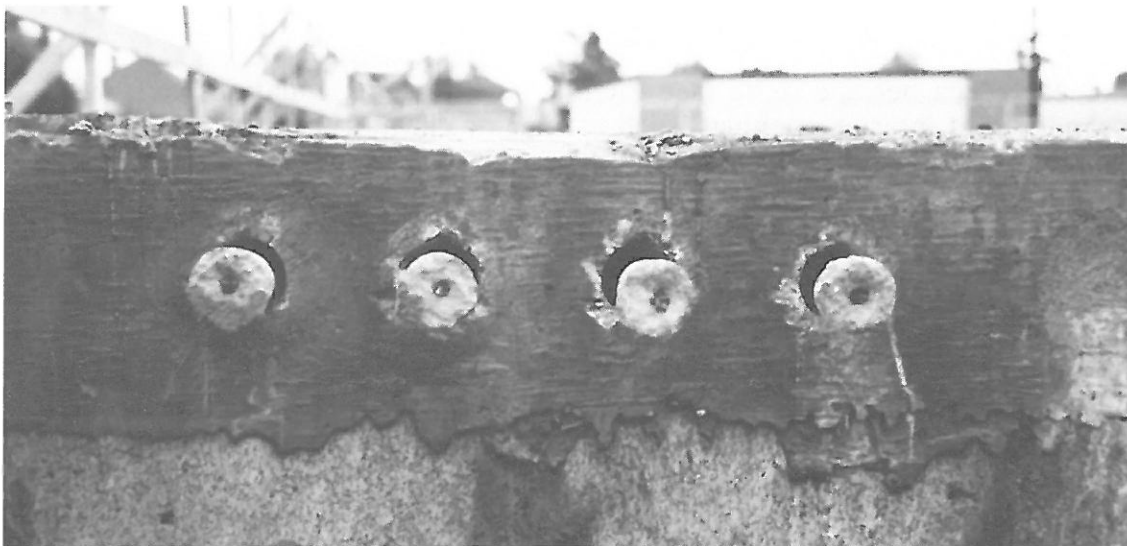
PICTURE 12: NOTE THE GROUT PLUG PUNCHED THROUGH BY THE KERN WIRE.

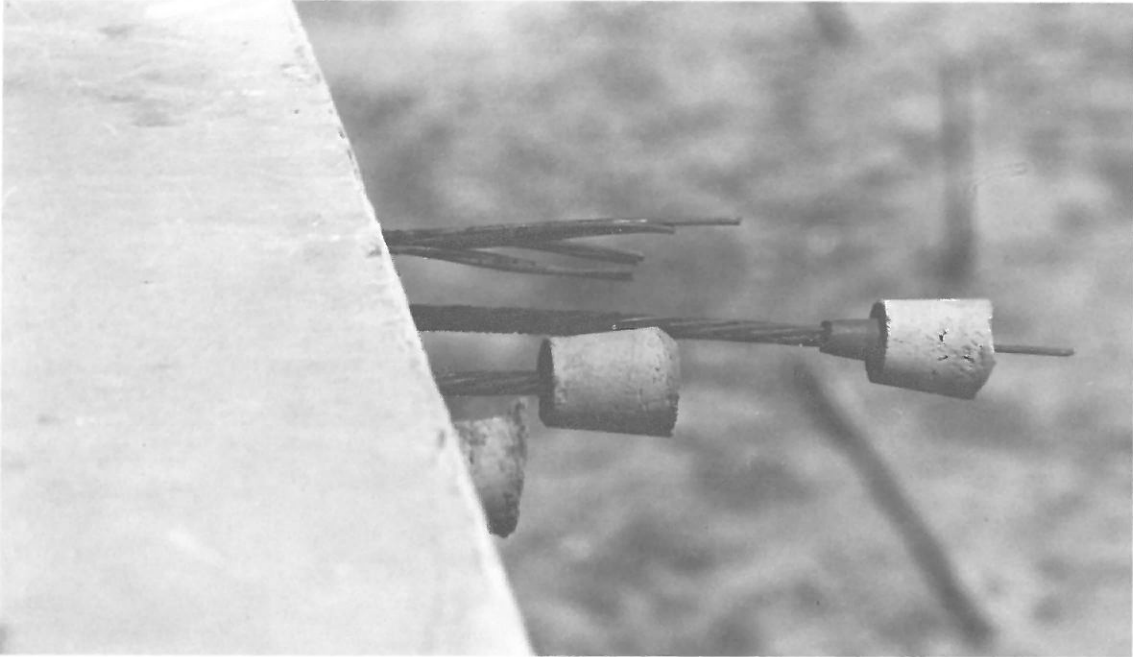
PICTURE 13: NOTE THE WEDGE INTACT BEHIND ONE OF THE GROUT PLUGS.

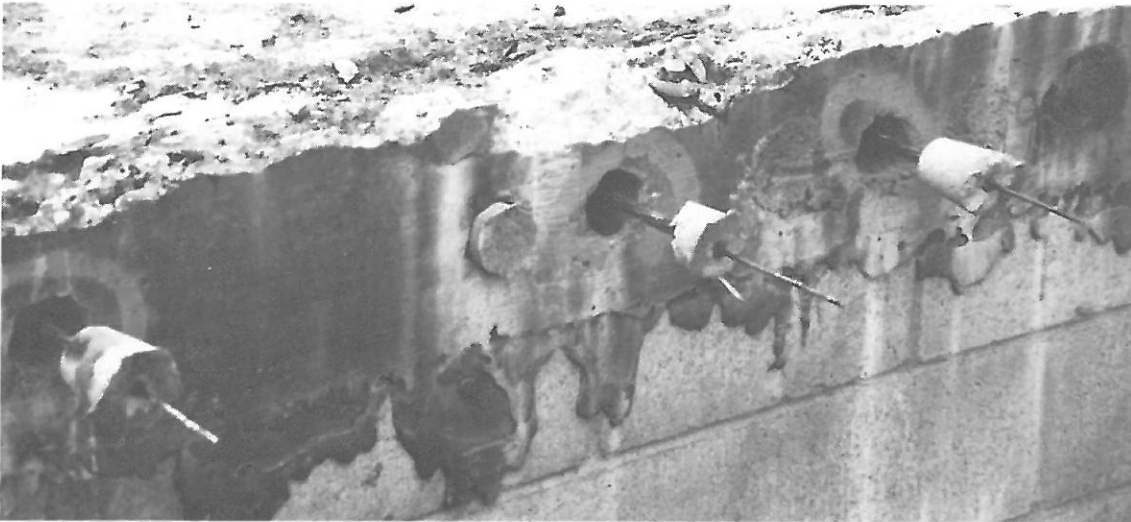
PICTURE 14: OBSERVE THE KERN WIRE EXTENSION BEYOND THE INTACT GROUT PLUG.

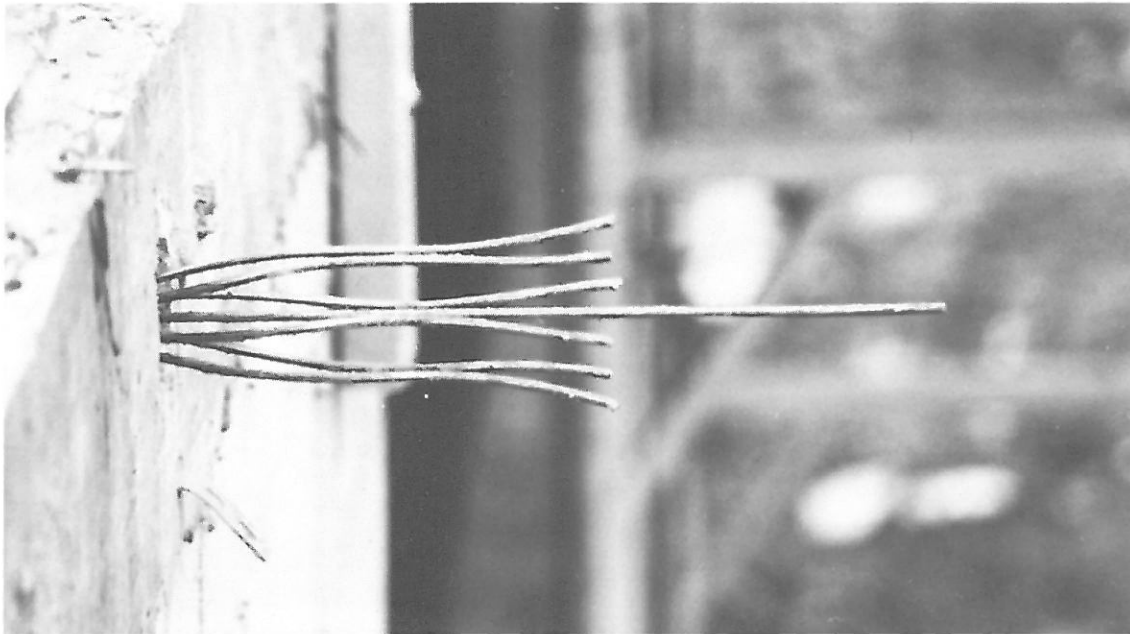
From the total of 962 tendons cut, 203 dislodged the wedges and the grout plug. From there, only 12% broke the bond between the strand and the grout plug, and in no event any strand ejected out of the slab edge more than 18 inches.

PICTURE 15: VIEW OF AN UNRAVELED STRAND AT SLAB EDGE.

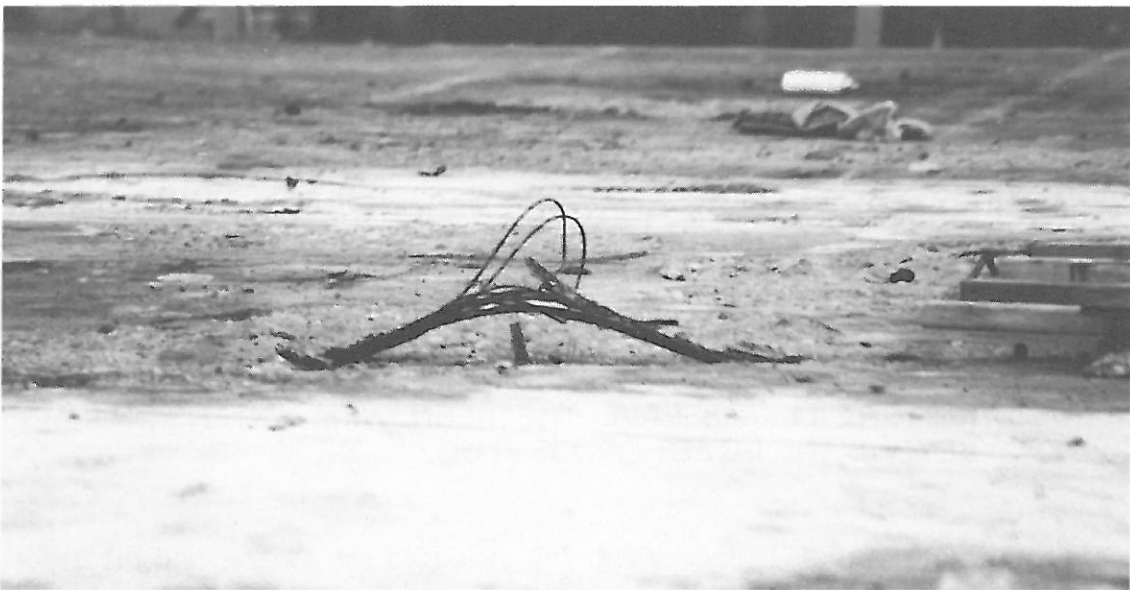
PICTURE 16: BLOWOUT OF STRAND FROM TOP OF SLAB.

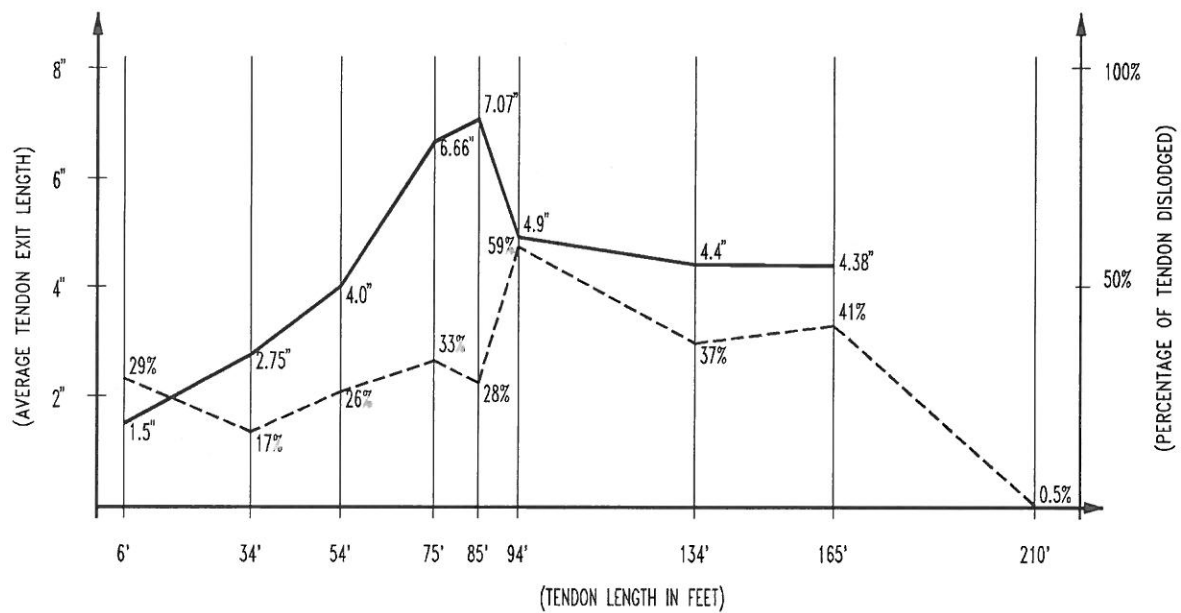
FIG. 7

The percentage of tendons which were dislodged, and the distance such tendons exited the slab edge are plotted as a function of their respective free lengths in Figure 7. The free length is the distance between the cut made in the tendon and the stressing pocket at the slab edge. Observe that tendons with a length between 75 to 95 ft. from the slab edge dislodged more often and exited farthest.

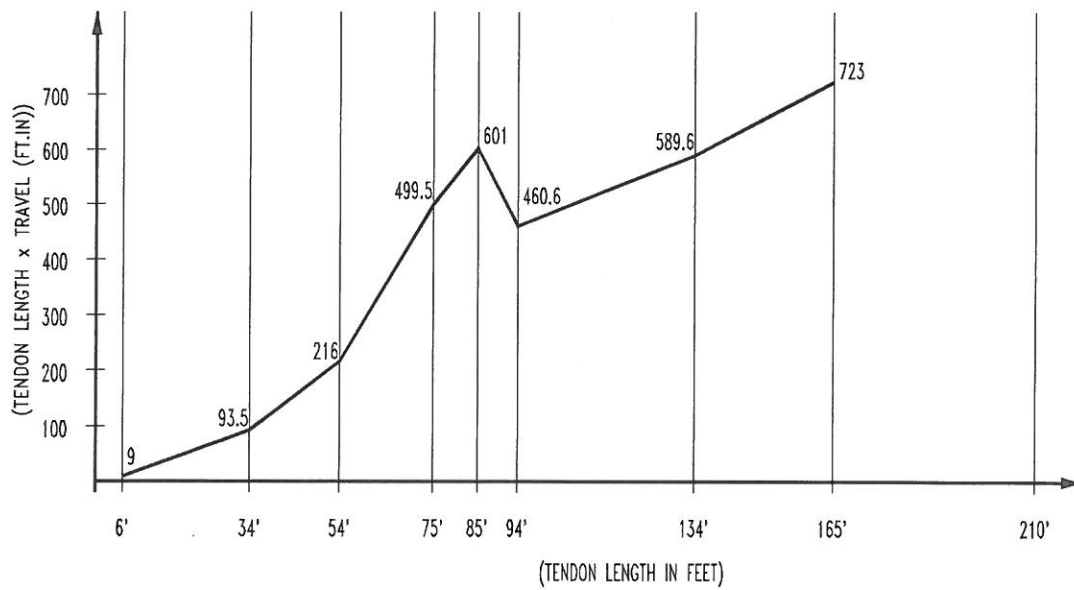
FIG. 8

Since at the cut, the force in the tendon vanishes, the pull out effort of the tendon from the slab edge may be related, among other parameters such as drape, to tendon's length. Tendon length times distance a tendon exits the slab edge, can then be regarded as a measure of energy expended by the slab and the grout pocket to resist the cut tendon. Figure 8 shows the variation of this energy measure with the free length of tendon. The Figure implies that in the event of a cut in the tendon, tendons with cuts further away from slab edge are likely to release more energy to the restraining environment.
